**New York Archaeological Council
Phase I Cultural Resource
Investigations: Reconnaissance
Phase IA Literature Search and Sensitivity Assessment for
Proposed
NYSEG CAES Project**

Reading Center Vicinity, Schuyler County, New York

December 16, 2011

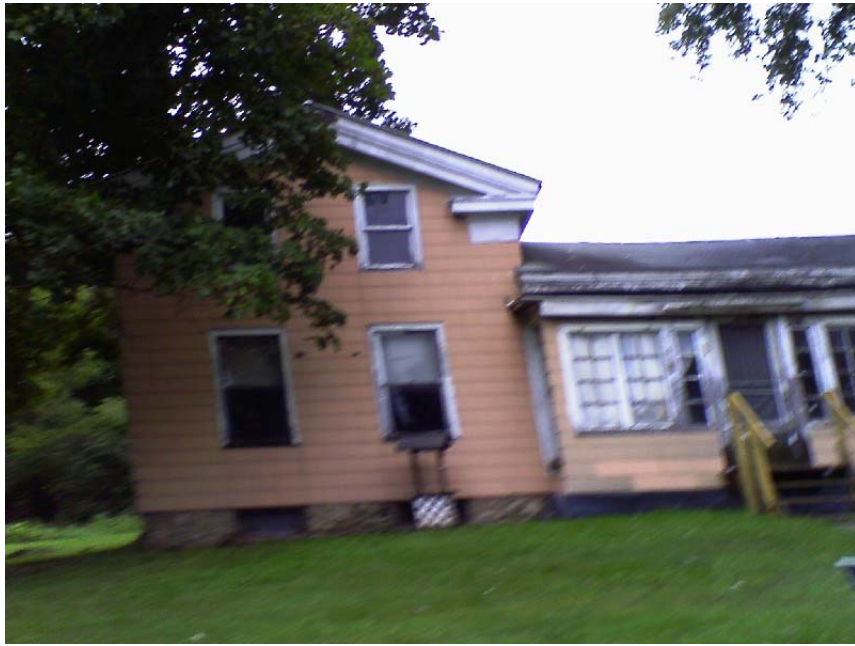
Photo Location: 1 | 4011 Rt. 14A; 9707.00010

Building Inventory Number	Property Description	Form Available	Photo Location
9707.007	2675 Cemetery Road	Yes	2
9707.0010	4011 Rt. 14 A	Yes	1
9707.0012	4489 State Rt. 14	Yes	5
9707.0009	3461 County Rt. 30/Salt Pt. Rd.	Yes; location unknown	4
9707.0003	Drovers Tavern	Yes; exact location unknown	N/A
9707.0001	John Ireland Manor House	Yes; exact location unknown	N/A
9707.0002	White Pump Tavern	Yes; exact location unknown, form illegible	N/A
9707.0008	2571 Church Rd; Morgan Farm	No form	3
9707.0016	4555 NY 14; Russell Residence	No form	6
9707.0015	2625 Spencer Rd.	No form	7
9707.0014	3451 Vanvleet Rd.	No form; however street maps over 6 miles sw of project site not within 2 mile indirect APE	N/A

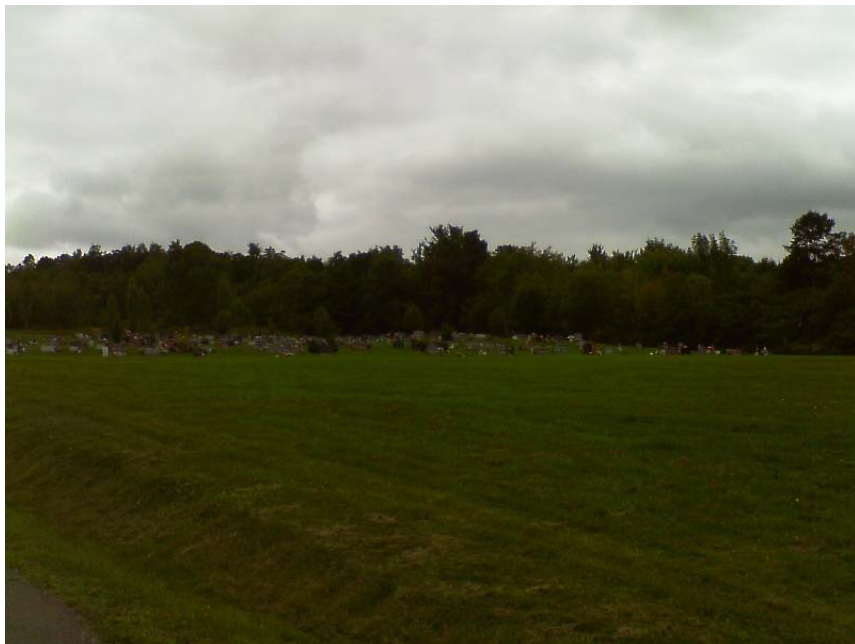
Photo Location: 17	Cemetery	
Compressed Air Energy Storage (CAES) Report	ERM	State Route 14A Reading, Schuyler County, NY

Property Location & Description	Photo Location
Route 14; Cemetery	17
3851 Rt. 28; Two story, rectangular plan, side-gabled house with five ranked windows with center door, asbestos shingle siding, exterior gable wall concrete block chimney, standing seam metal roof and full width front porch supported by a spindlework frieze and bracketed columns..	20
3921 Rt. 14A; One and a half story house with an asymmetrical plan vinyl siding and an asphalt shingle roof.	22
Route 14A; One and a half story house with rectangular plan, 1/1 light windows, and front porch supported by square columns on square piers.	23
3811 Rt. 14; One and a half story house with a dual pitched hipped roof with asphalt shingles, vinyl siding and enclosed front porch.	25
3815 Rt. 14- Chieftain Motel; One story mid twentieth-century roadside motel with exterior entrances to the rooms	26
Rt 14; house next to Chieftain Motel. The house appears to be comprised of at least two different blocks or volumes; a square 4 ranked block and an L-shape block with a porch.	26

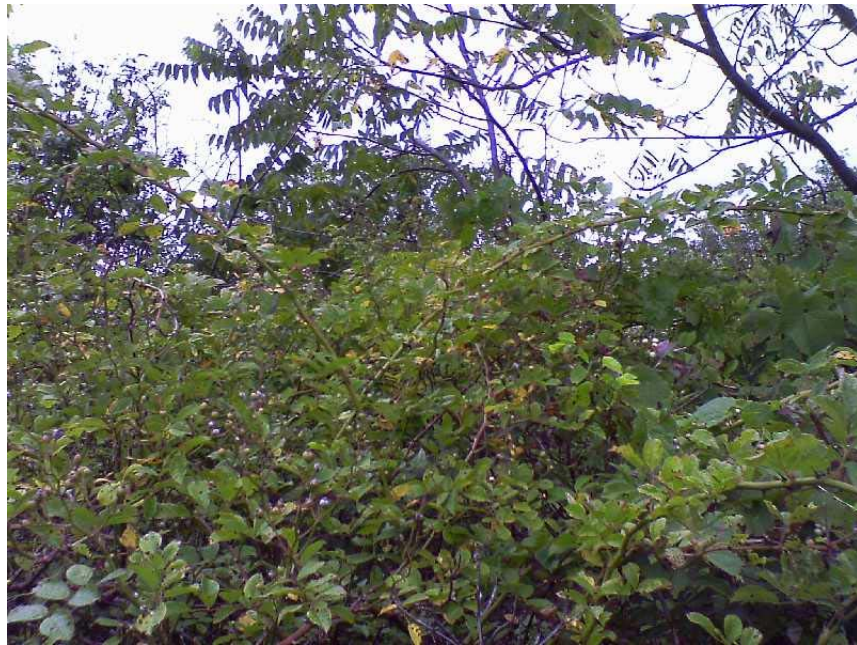
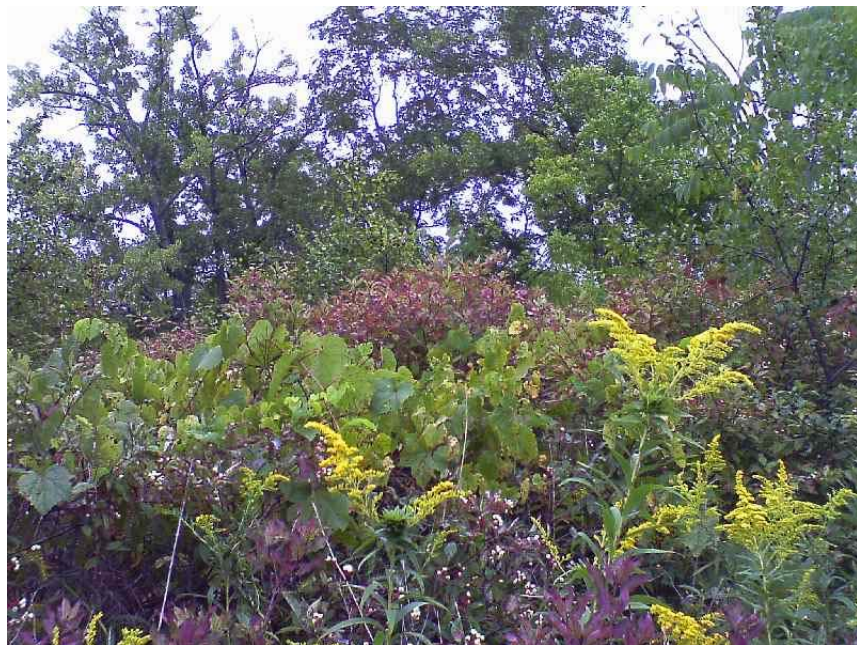
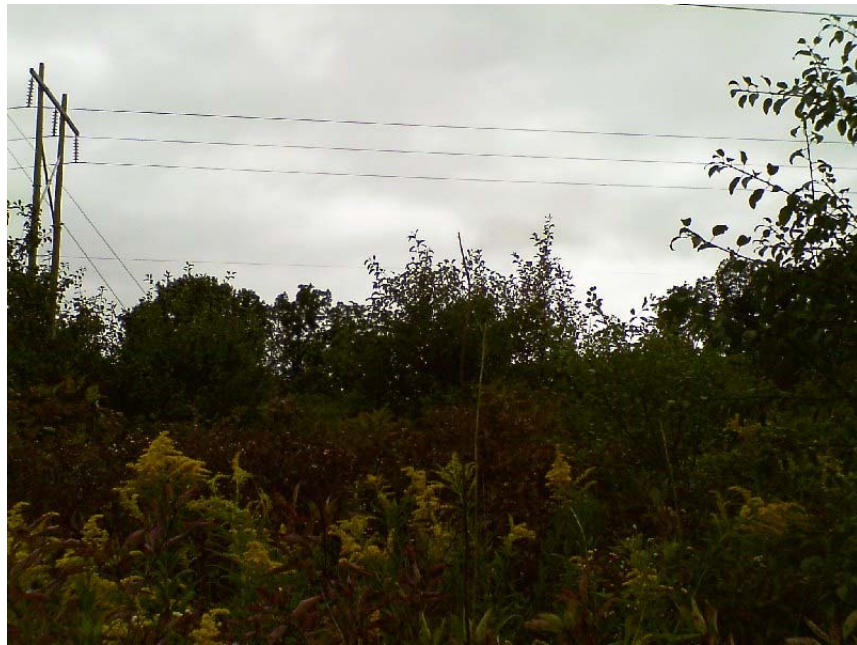
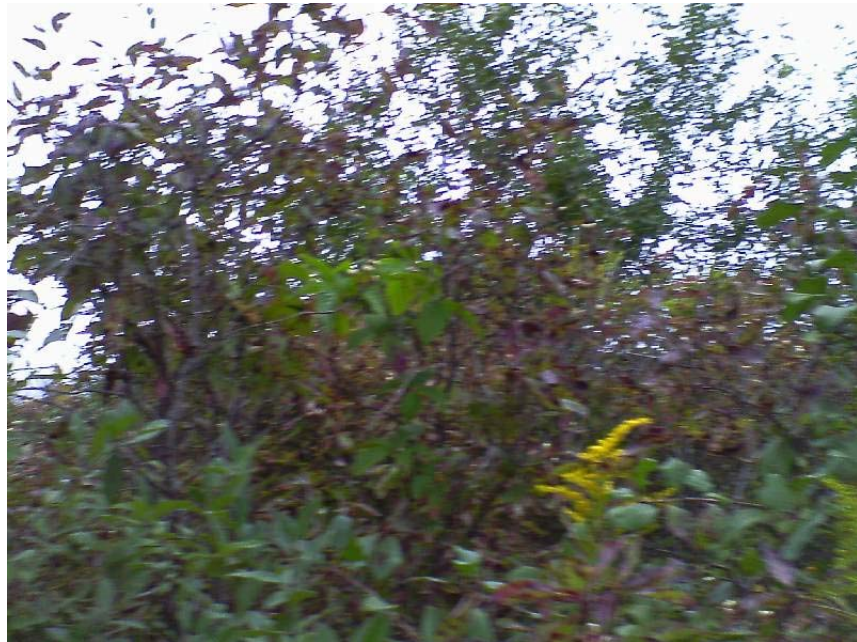
Photo Location: 10	<i>Approximate center of proposed substation location, looking east.</i>	
<i>Compressed Air Energy Storage (CAES) Report</i>	ERM	<i>State Route 14A Reading, Schuyler County, NY</i>

Photo Location: 10	<i>Approximate center of proposed substation location, looking south.</i>	
<i>Compressed Air Energy Storage (CAES) Report</i>	ERM	<i>State Route 14A Reading, Schuyler County, NY</i>

Photo Location: 10	<i>Approximate center of proposed substation location, looking west</i>	
<i>Compressed Air Energy Storage (CAES) Report</i>	ERM	<i>State Route 14A Reading, Schuyler County, NY</i>

Photo Location: 10	<i>Approximate center of proposed substation location, looking north</i>	
<i>Compressed Air Energy Storage (CAES) Report</i>	ERM	<i>State Route 14A Reading, Schuyler County, NY</i>

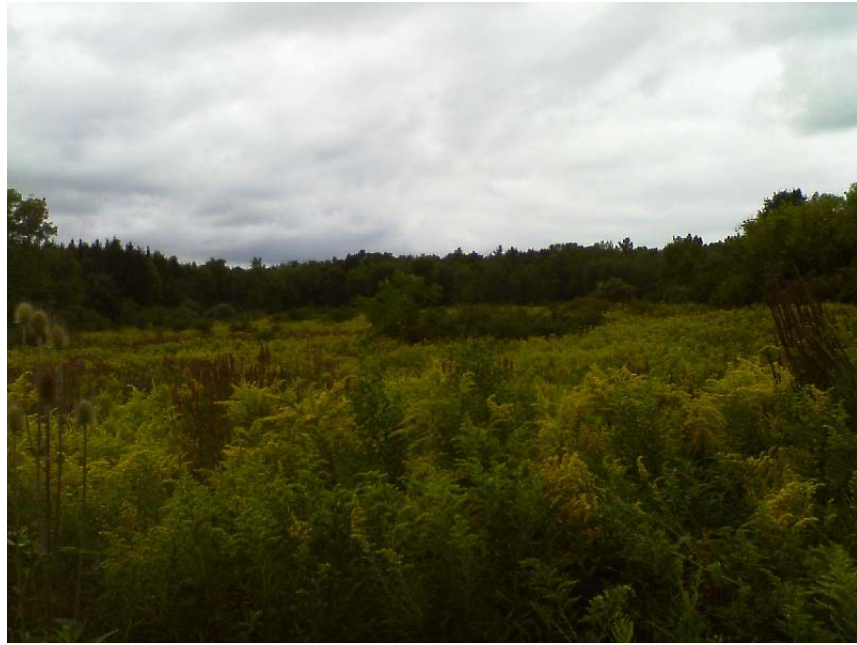
Photo Location: 16 | Looking into project area from Rt. 14A, looking south – plant location

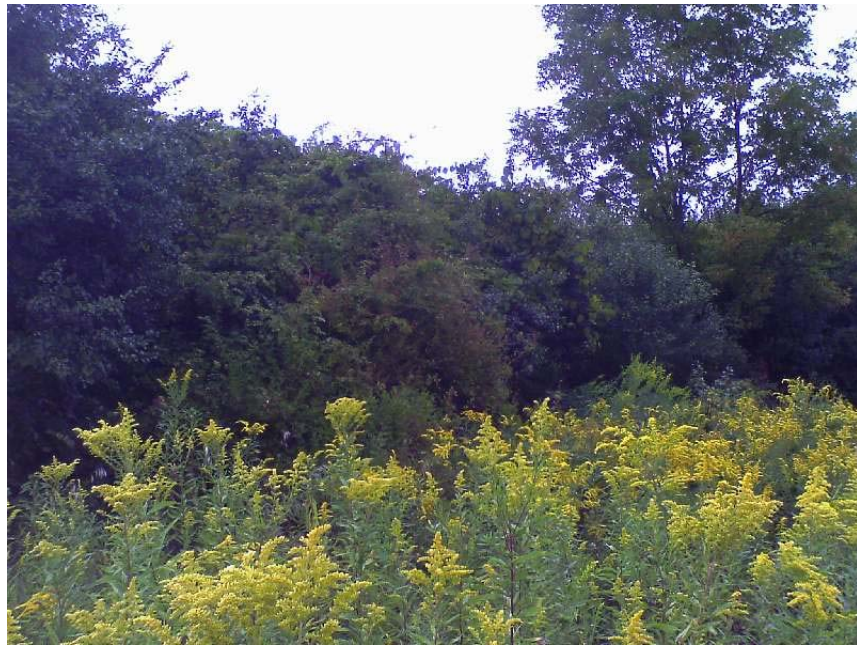
Photo Location: 13 | Looking northwest within project area – plant location
