Arizona-Southern California Outages on September 8, 2011

Causes and Recommendations

Federal Energy Regulatory Commission

North American Electric Reliability Corporation

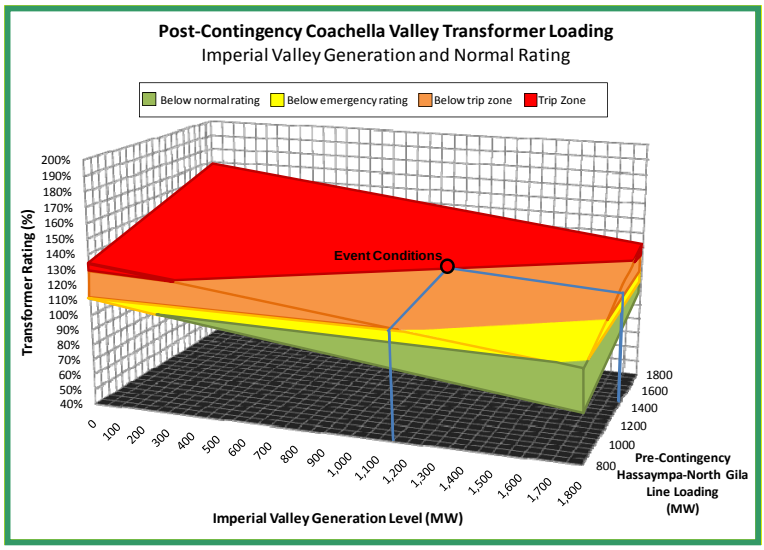
Figure 7 : Post-Contingency CV Transformer Loading Based on Imperial Valley Generation

In general, adding generation in San Diego, CFE, or Imperial Valley and backing down generation in APS's system (east of Path 49) would reduce the loading on IID's 92 kV system for the loss of H-NG. For example, an additional 600 MW of generation at Imperial Valley and a reduction of generation in APS's system by the same amount would have reduced the pre-contingency loading on H-NG by 20% and improved the post-contingency voltage in WALC's Blythe area by approximately 4%. Under this condition, the loading on the CV transformers for the loss of H-NG would be approximately 111% of their normal rating (166 MVA), well below their trip setting of 127%. This is a further demonstration of the importance of including all facilities when deriving SOLs.

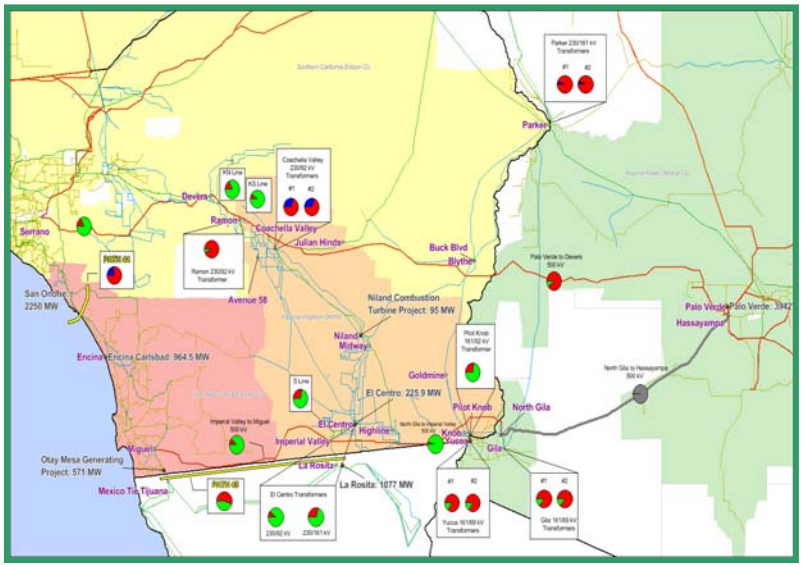
15:27:39 – The Hassayampa- North Gila 500 kV line tripped.

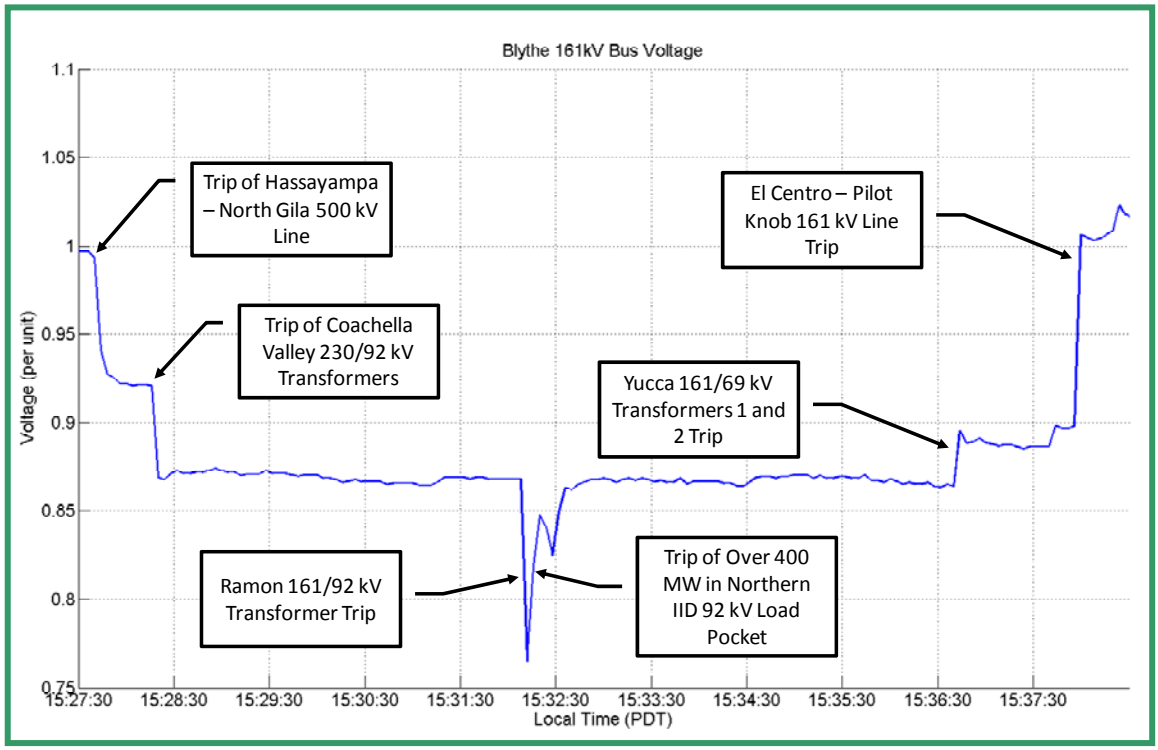
Figure 8: Blythe 161kV Voltage

On September 8, 2011, CAISO had partial visibility of IID's system, but could not see that the CV banks had tripped. Prior to the event CAISO and IID had been working together to increase their mutual visibility and those efforts are continuing. Currently, CAISO receives loading data from the 230 kV side of the CV transformers.

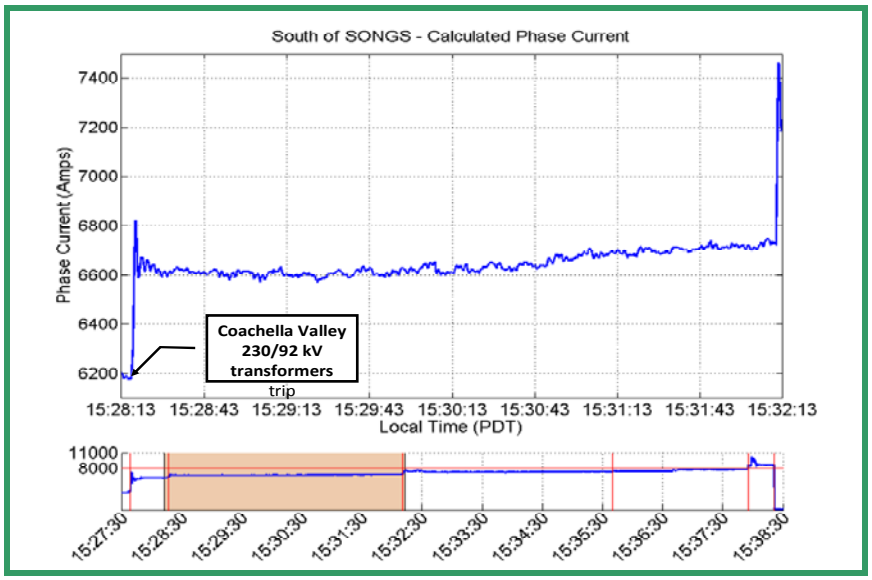
15:28:17 – Two Coachella Valley 230/92 kV transformers and the Coachella Valley Ramon 230 kV "KS" line tripped. (030)

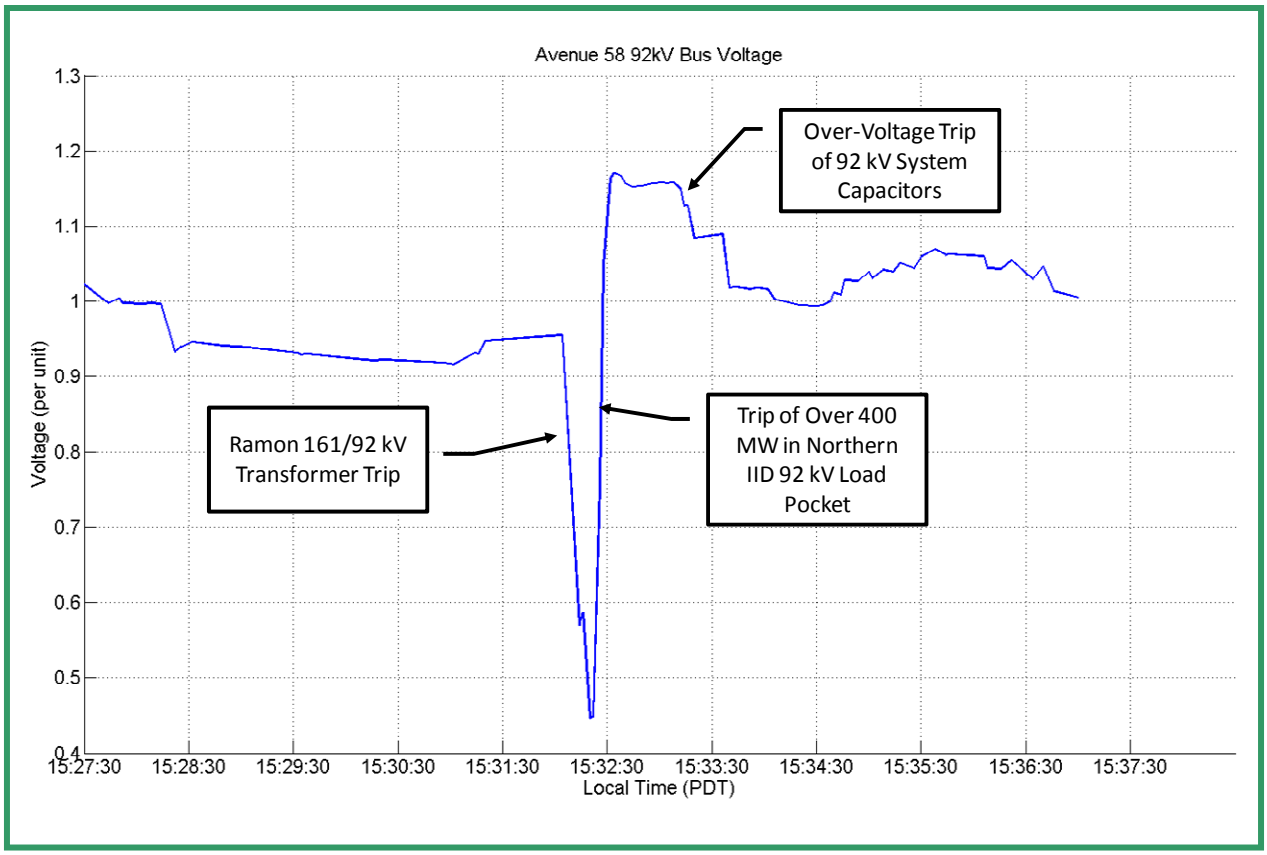
Figure 9: 92kV Voltage (per unit) at Avenue 58

The loss of IID's northern resources and subsequent system response caused IID to lose multiple generators connected to its 92 kV system, including IID's Niland Gas Turbine 2 (generating 45 MW), IID's CV Gas Turbine 4 (generating 20 MW), independent power producer Colmac's unit (generating 46 MW), and IID's Drop 4 Unit 2 Hydro Generator (generating 10.3 MW).

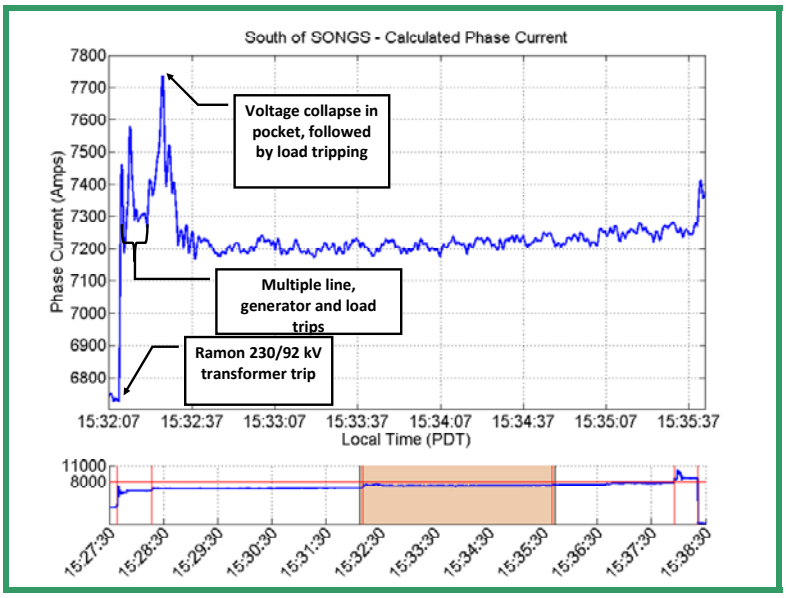
Time: 15:32:10 – The Ramon 230/92 kV transformer tripped and IID shed 444 MW of load. (110)

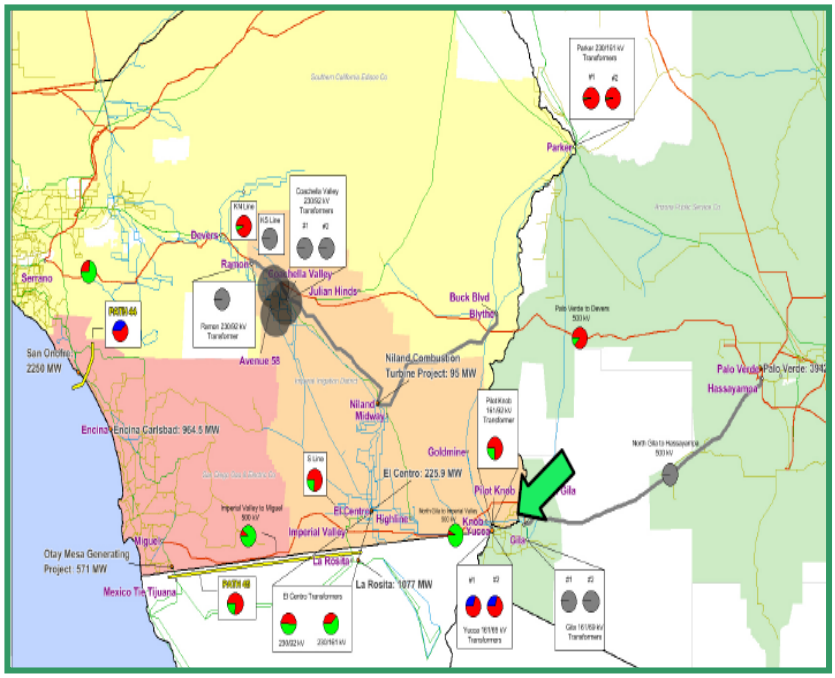
Time: 15:35:31 – Yuma Cogen (YCA) tripped. (180)

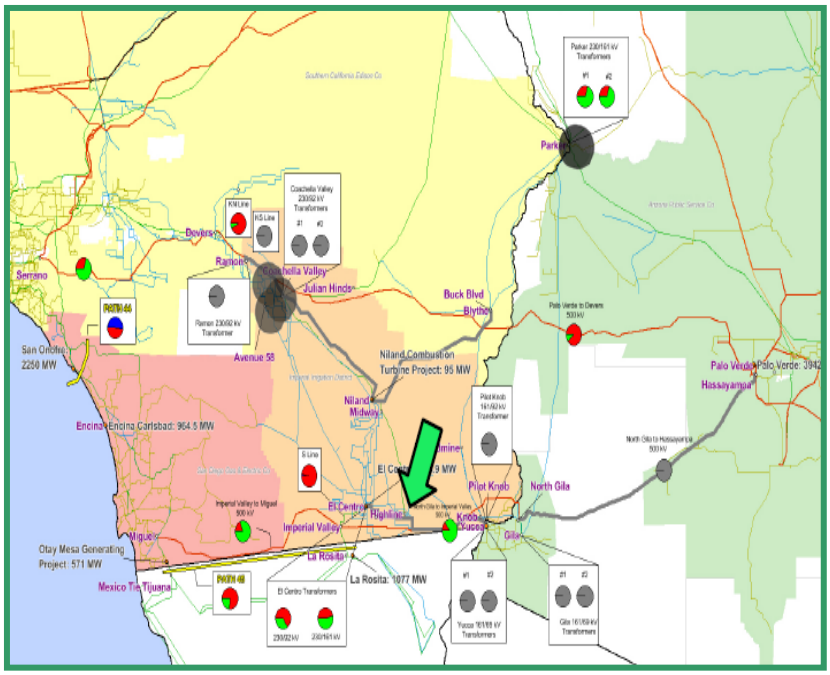
Time: 15:37:55 – The El Centro-Pilot Knob 161 kV line tripped. (230)

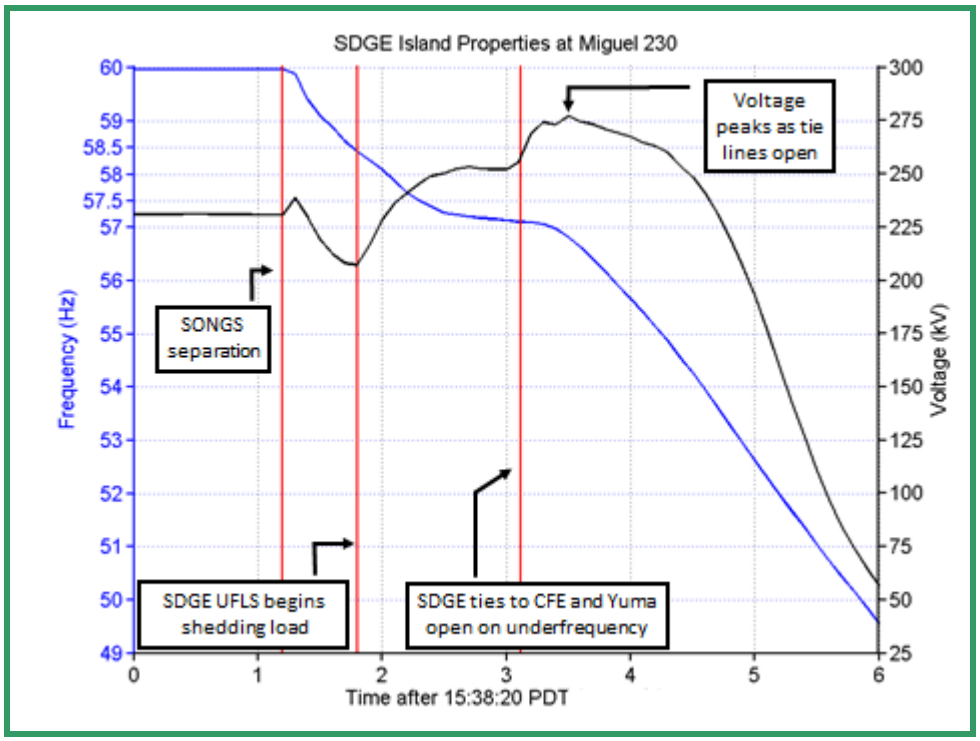
Figure 10: Frequency, Voltage in the SDG&E/Yuma/CFE Island

[54] The fact that several generators tripped during load shedding suggests that CFE may benefit from analyzing whether its UFLS program and generator underfrequency protection systems are coordinated.

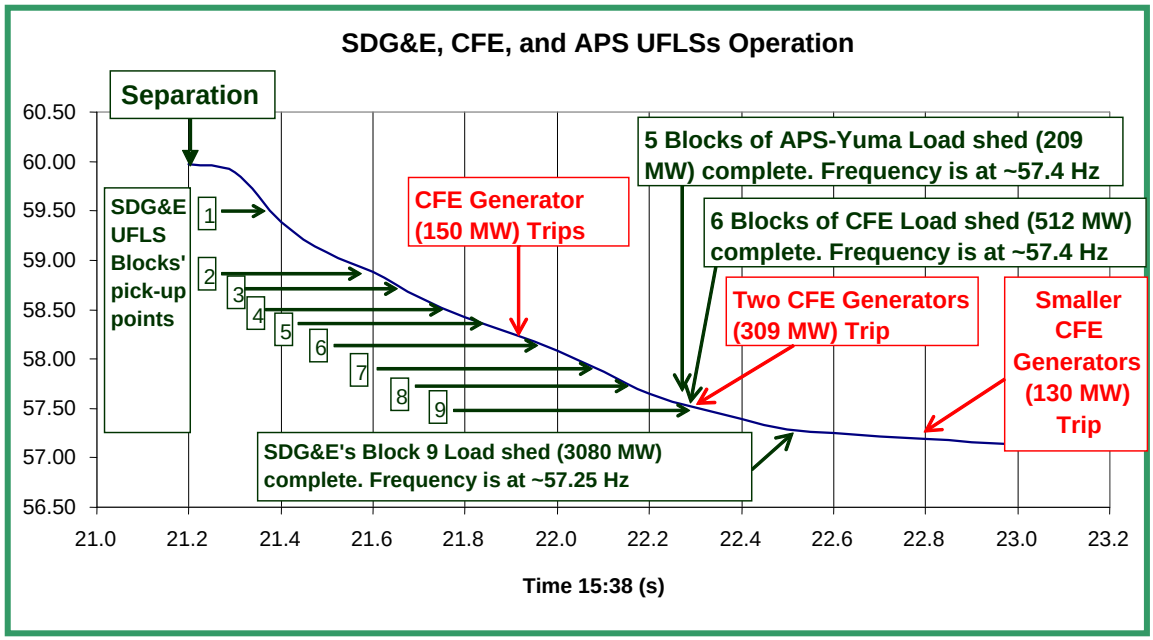
Figure 11: Frequency Performance in the SDG&E/Yuma/CFE Island

The CFE island separated from SDG&E after their only two remaining ties tripped in rapid succession. At 15:38:22.2, the Otay Mesa-Tijuana 230 kV transmission line open-ended at Tijuana in CFE's territory due to underfrequency protection.[55] Less than a second later, at 15:38:23.13, the Imperial Valley-La Rosita 230 kV transmission line open-ended at Imperial Valley in SDG&E's territory by underfrequency protection.[56] According to CFE, its UFLS program was not designed for the operation of a SDG&E/CFE/Yuma island, but for the operation of a "southern WECC island."

The Yuma island separated from SDG&E at 15:38:23.12, when the Imperial Valley-North Gila 500 kV transmission line tripped by underfrequency protection. APS's UFLS operated on 26 out of the 28 feeders in the Yuma area prior to the loss of the local Yucca steam generators that were on line. However, there was insufficient local generation to stabilize the load pocket in Yuma. At 15:38:38, the Yuma island internal units tripped on underfrequency protection.

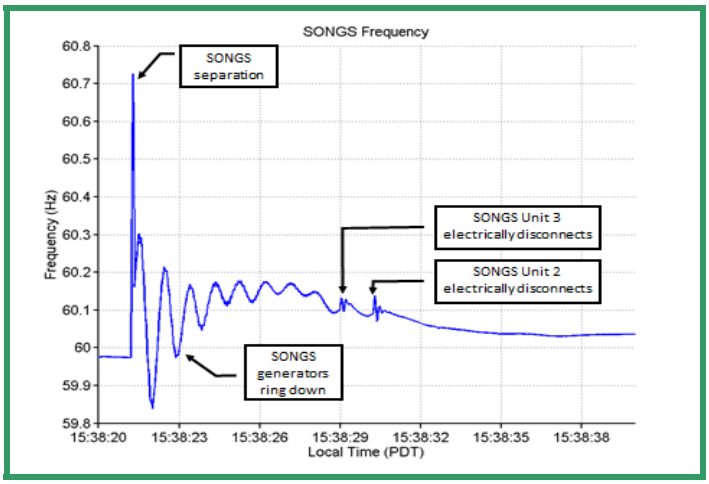
Figure 12 : Frequency Excursion in WECC Interconnection Immediately after the SONGS

shut down, at 15:38:30.209, SONGS Unit 2 electrically disconnected from the system. Loss of the 2,300 MW of SONGS' generation effectively reduced the loss of load for the main body of the Western Interconnection from a 3,400 MW loss to a net 1,100 MW load loss. This made the recovery from the resulting overfrequency event much easier. The SONGS generators did not lose offsite power because the SONGS switchyard was still connected to the SCE system.

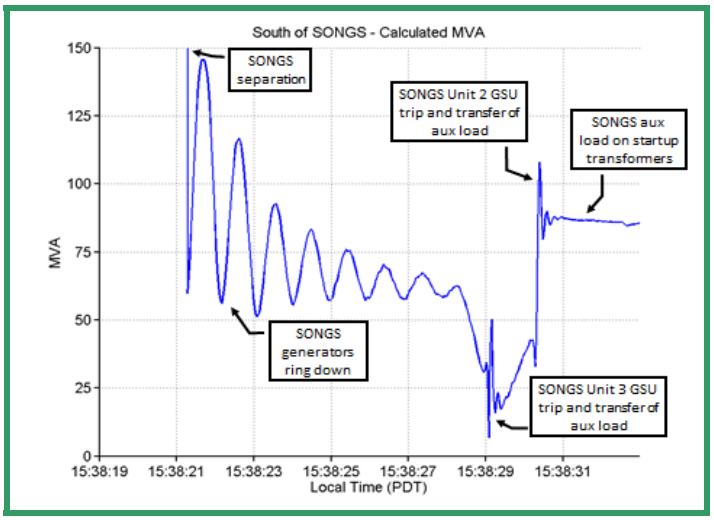
Figure 13: SONGS Generation Trips and Auxiliary Loads Transfer to 230 kV Bus

Although the SONGS generators remained connected to the SCE side of the switchyard at SONGS, at about 15:38:27.5, or approximately six seconds after the SONGS separation scheme initiated, the SONGS turbines both experienced a brief acceleration in speed and tripped due to turbine control logic. At the same time, local system frequency at SONGS was observed to spike from 59.974 Hz to 61.203 Hz. After the initial impulse caused by the system separation, the frequency in the main body of the Western Interconnection peaked near 60.170 Hz. This can be seen on Figures 12 and 13, on the next page. The turbine trip initiated a reactor shutdown, and the units began coasting down. A little more than a second later, at 15:38:28.963, SONGS Unit 3 electrically disconnected from the system, and less than three seconds after the reactors

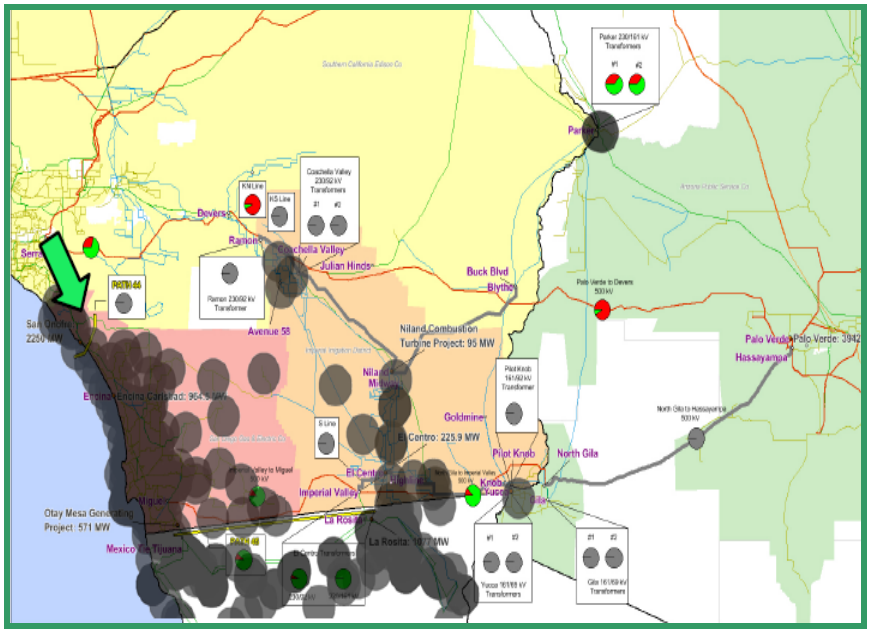
Time: 15:38:30 – The South of SONGS Separation Scheme operates and both SONGS units tripped. (300)

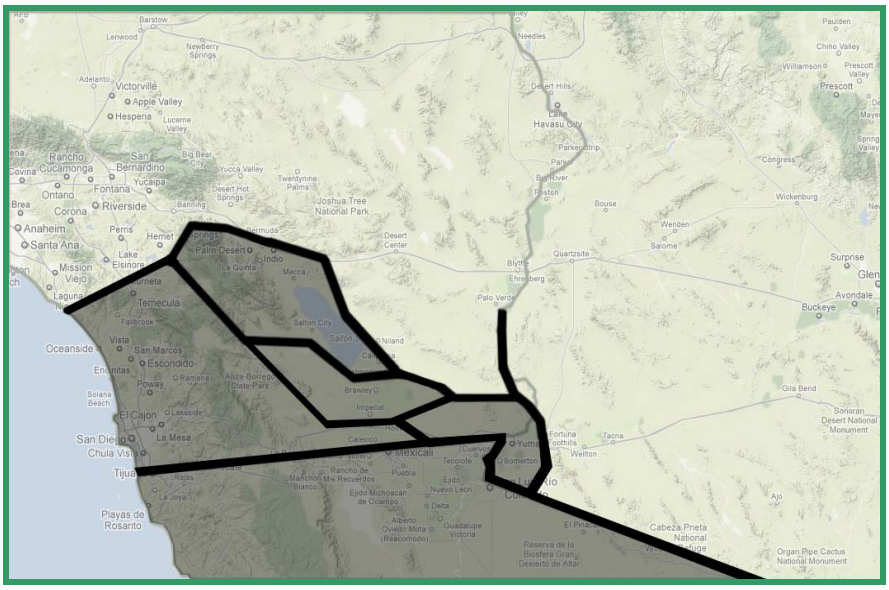
SDG&E, CFE, and Yuma Blackout (by 15.38.30)

By 15:38:38, the SDG&E, CFE and Yuma islands had all collapsed, leaving approximately 2.7 million customers without power.

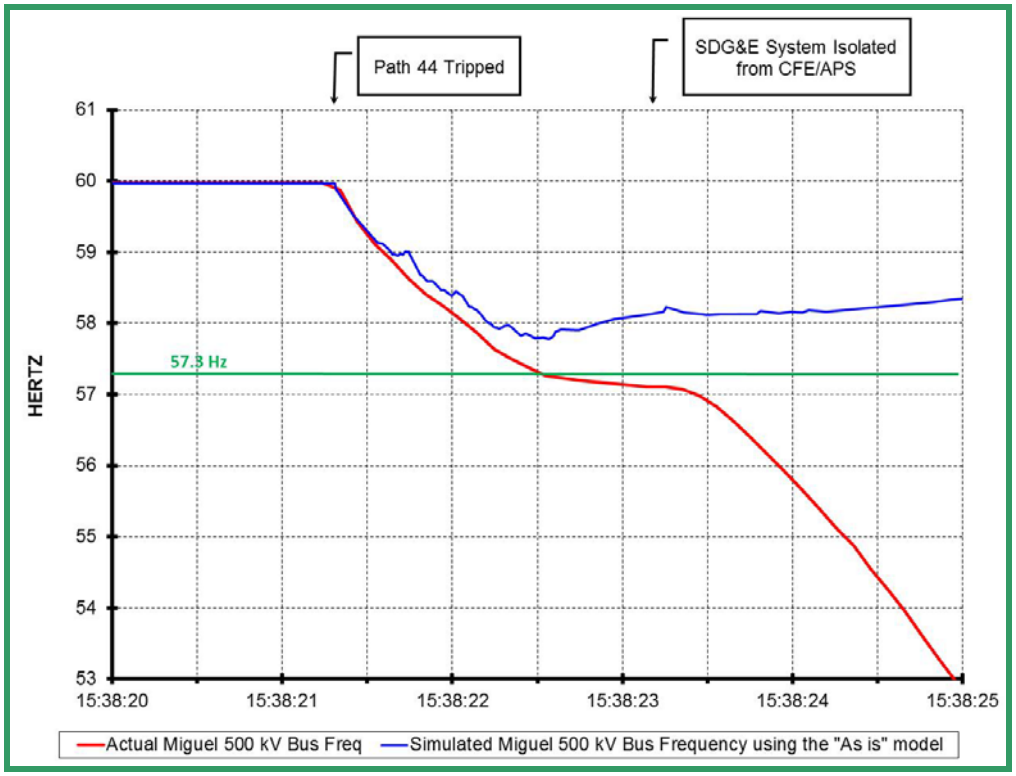
Figure 14: Actual and Simulated Frequency at Miguel 500 kV Bus

The inquiry's Modeling and Simulation team was able to obtain a simulation more closely aligned with actual measured performance by performing several sensitivity studies and adding details from the actual event, including UFLS performance, PMU

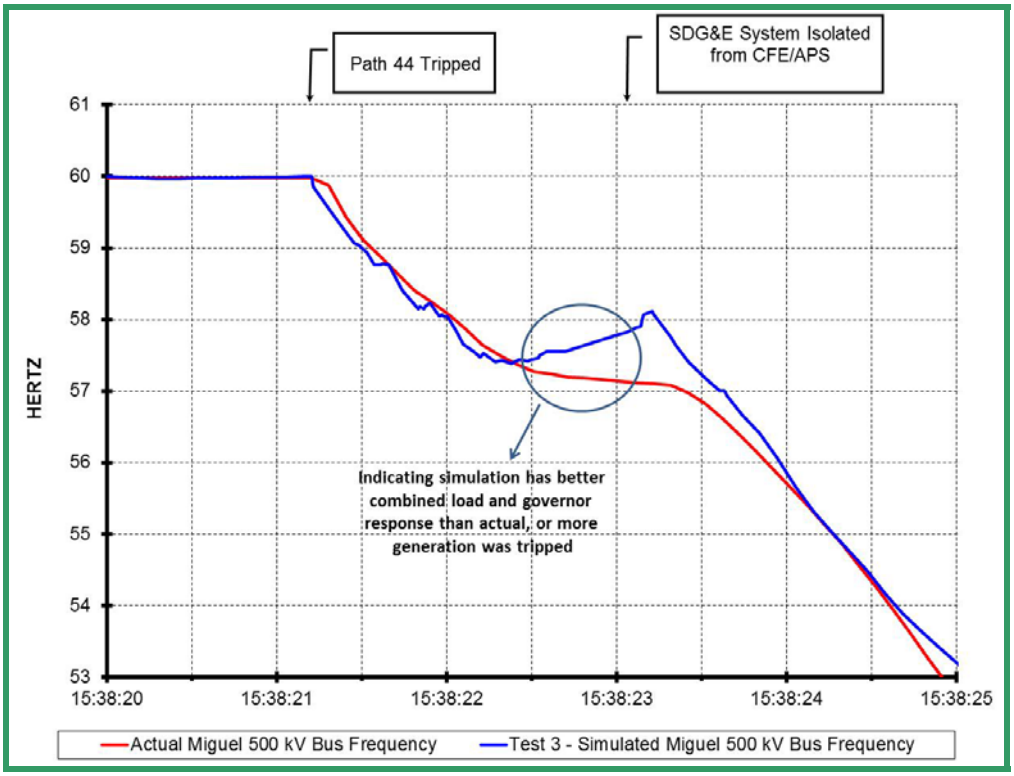
Figure 15: Miguel Frequency Actual and Simulated for "Test 3"

The simulation studies explain the ineffectiveness of the UFLS program, despite up to 75% of SDG&E load that was shed within 1.3 seconds of the SONGS separation scheme operating. The simulation analysis confirmed findings in the inquiry's SOE that the frequency collapse was caused by generation trips and UFLS misoperations within CFE shortly after Path 44's separation, followed by additional generation trips within SDG&E around the time it separated from CFE/APS.

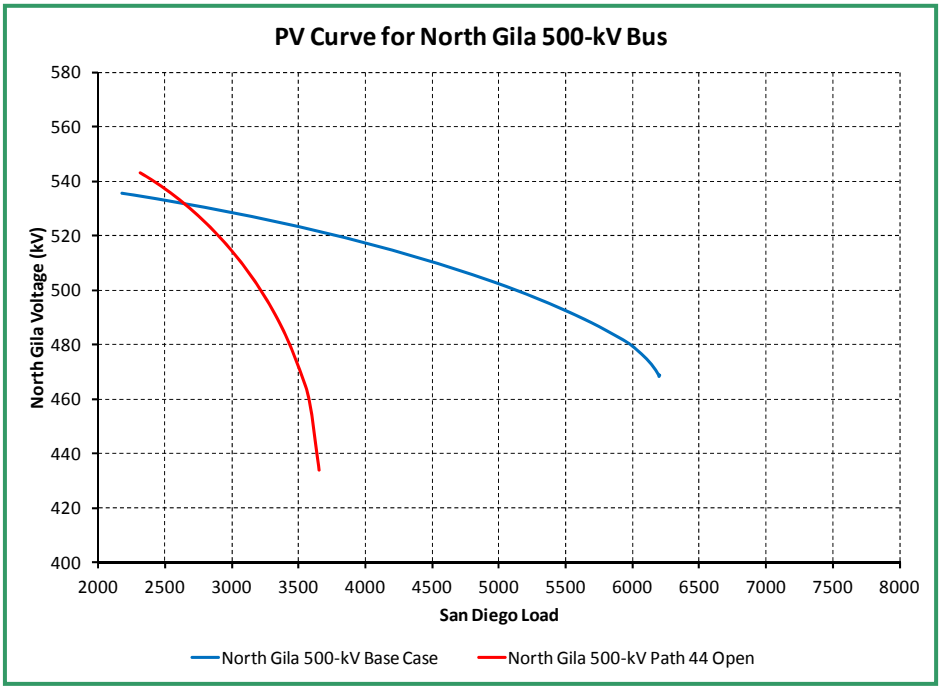
Figure 16: PV Curve for North Gila 500 kV Bus

Specifically, the system is most likely to collapse when the SDG&E load exceeds 3,500 MW. In 2010, SDG&E's load exceeded this amount for 851 hours,[97] meaning that

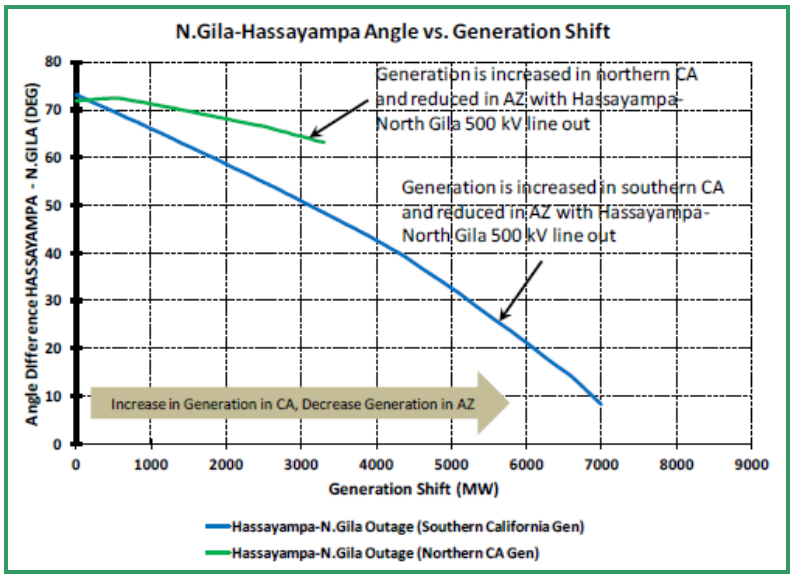
Figure 17: Phase Angle of H-NG vs. Generation Shift

The blue line in Figure 17 illustrates that with the particular conditions of the September 8th event, approximately 1,800 MW needed to be redispatched on both ends of H-NG (and close to the terminals, in Southern California and Arizona) in order to close the voltage phase angle from 72 degrees to 60 degrees (i.e., to within the permissive 60 degree setting of the synchro-check relay). The green line shows that more generation—more than twice as much—must be redispatched if units are chosen in Northern California to close the angle between Hassayampa and North Gila.
